Structural reports and structural reinforcement projects

Report and design of structural reinforcement for a concrete slab cutout, preventing the structural collapse and further damage to the historic heritage of the B3 building (Stock Exchange), located in the square Antônio Prado in downtown São Paulo, Brasil.

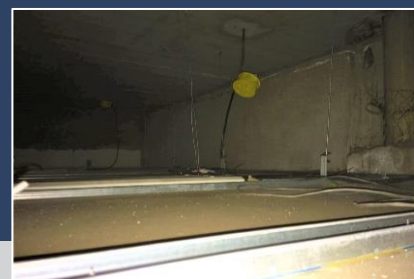
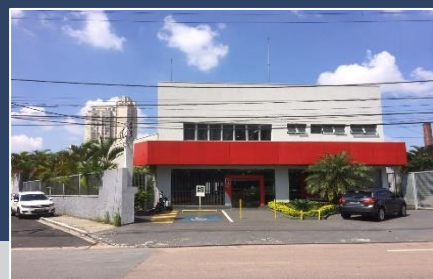
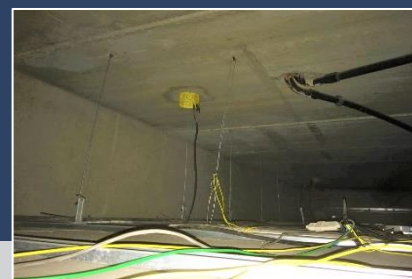
Structural Reinforcement Report and Project to determine the necessary reinforcements in the beams for setting up a concrete slab cutout, further enabling the passage of the new elevator to suit the accessibility standards.

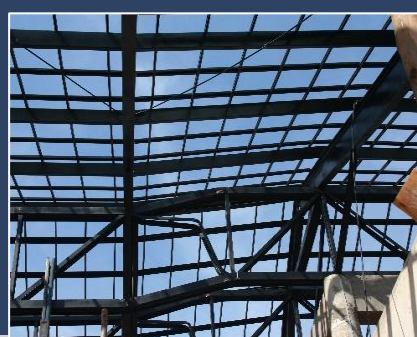
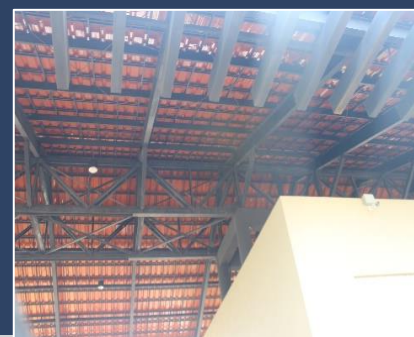
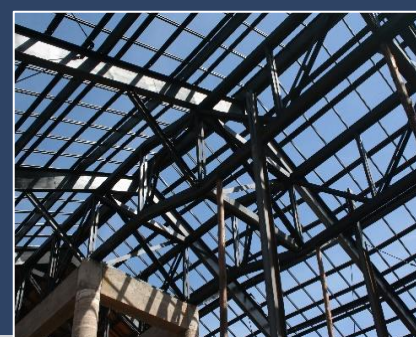
Due to dimensioning problems in the metal profiles, defective welds and loose connections, the metal structure partly gave way, before the assembly phase of the structure had even finished. JGV Engenharia was responsible for preparing the report and structural reinforcement projects for the roof, filling a span of 50 meters in metallic structure and ceramic tiles.

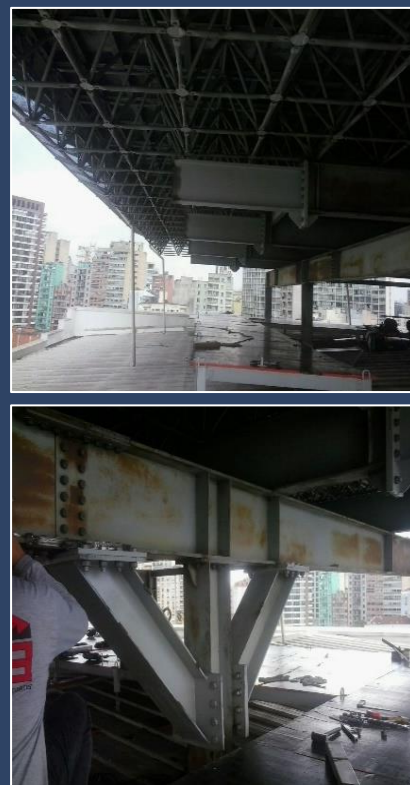
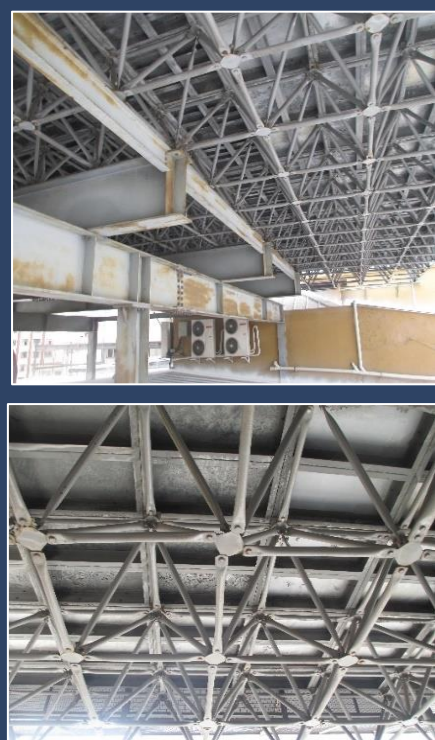
The Helipad in downtown São Paulo used to suffer from structural displacements caused by the aircraft landing and take-off operation, due to dimensioning problems aggravated by the oxidation of the bars and tubular connection nodes. JGV Engenharia indicated and designed all reinforcement measures and structural recovery of the Helipad, improving the distribution of loads in the special structure and treating pathologies, enabling the return of Helipad operations.

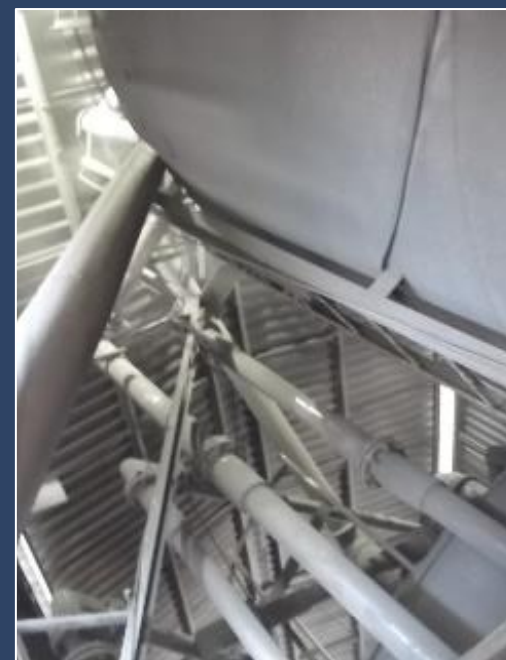
Report and Structural Reinforcement Project for the installation of two new silos in existing structure, one weighing 100 tons and the other 150 tons, at Metso Fundição in Sorocaba / SP.

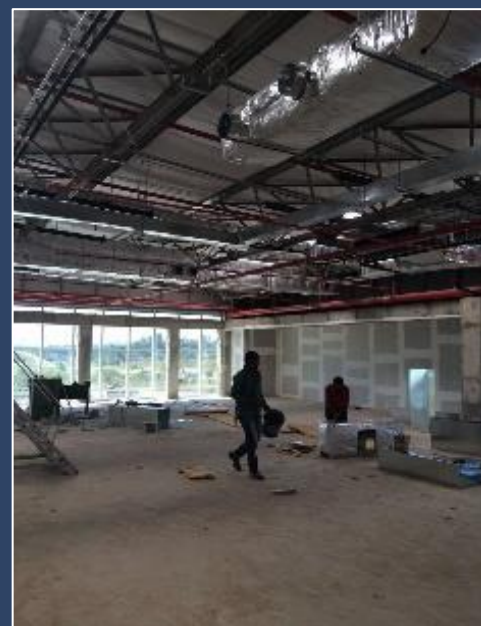
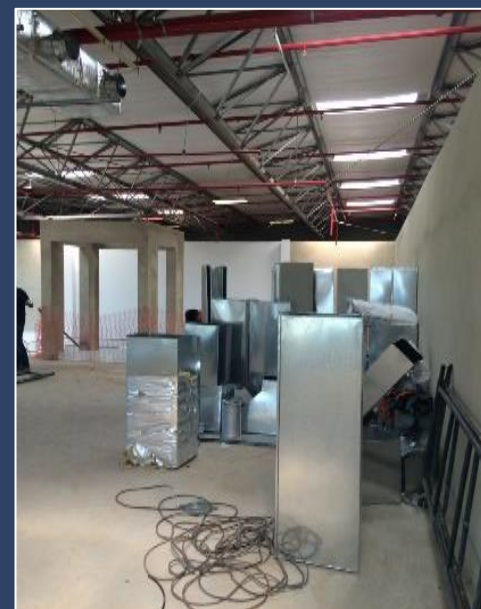
Report and Structural Reinforcement Project developed for the installation of retractable partitions and lining on the top floor of one of the Flex company's buildings in the Sinctronics building in Sorocaba / SP. The reinforcement was designed after the execution of the entire infrastructure of sprinklers, lighting, air conditioning, electrical and plumbing. Therefore, it was necessary to carry out a complete survey of all interferences at the site, and the reinforcements designed needed to be fully screwed at the site.

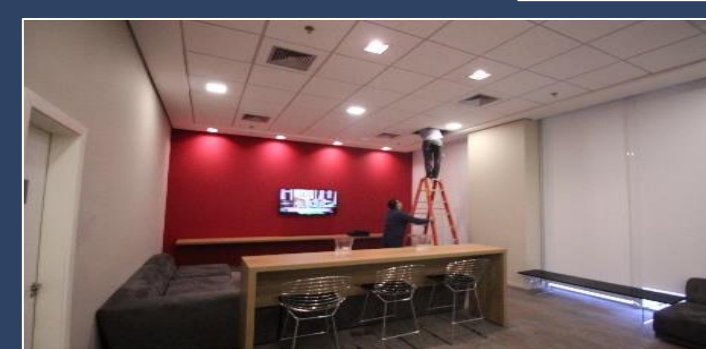
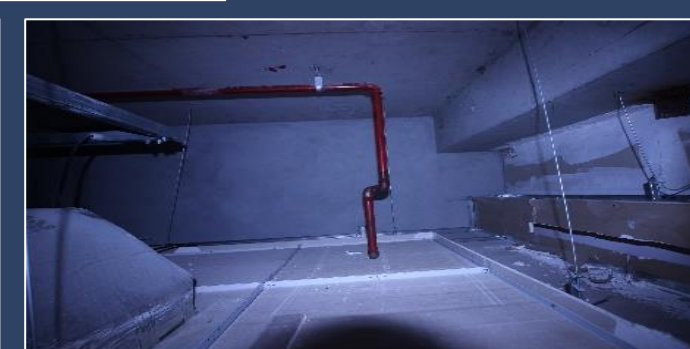
Structural Report and Structural Reinforcement Project developed for the installation of two safes in one of Banco Bradesco Cartão's offices, where the reinforced concrete slab would not support the increased load of the two safes. With this in mind, JGV Engenharia designed the structural reinforcements to redistribute the loads to the building's beams and pillars. The challenge in this case was to ensure that the reinforcements were executed without interfering in the building's infrastructure, such as electrical, hydraulic, sprinklers and air conditioning.
